International Journal of Engineering Sciences & Research Technology

**INTERNATIONAL JOURNAL OF ENGINEERING SCIENCES & RESEARCH
TECHNOLOGY****EVALUATION OF STRUCTURAL BEHAVIOR AND MECHANICAL STRENGTH
OF MULTIPLE-LEAF MASONRY WALLS AT JEDDAH'S HERITAGE BUILDINGS
UNDER UNIAXIAL COMPRESSION LOADS AND THEIR APPROPRIATE
STRENGTHENING TECHNIQUES****Hassan Salah Mahmoud^{*1}, Yaser Yehya Abdel-Aty² & Abdalnaser Abdulrahman Al-Zahrani³**¹Department of Conservation, Faculty of Archaeology, Cairo University, Giza, Egypt²Department of Conservation, Faculty of Archaeology, Cairo University, Giza, Egypt³Department of Archaeology, Faculty of Tourism and Archaeology, King Saud University, Riyadh,
Kingdom of Saudi Arabia

The current work represents the results of the intensive experimental study of the outer leaves of the multiple-leaf load bearing masonry walls in Jeddah's heritage buildings at Kingdom of Saudi Arabia (KSA). It studies the structural behavior and mechanical properties of the walls and their stone units under uniaxial compressive standard tests. Besides, it evaluates their strengthening and retrofitting by using a number of techniques, mainly, bedjoints reinforcement and nanolime

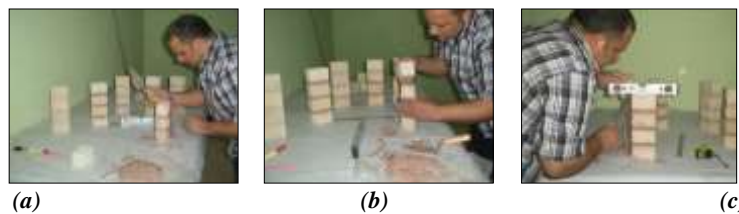
Figure. 2: During the stone masonry prisms construction.

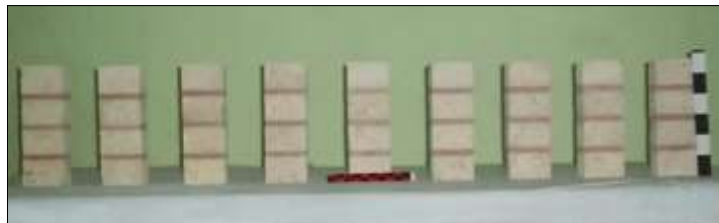
Figure. 3: The tested stone masonry prisms.

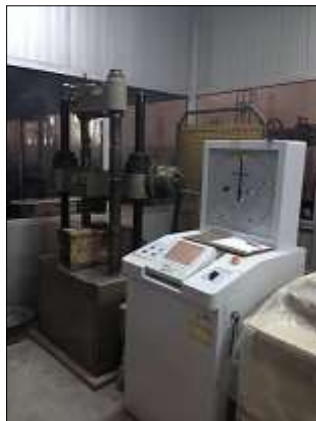
Figure. 8: 500 kN Shimadzu testing machine.

Prior to testing, all loading surfaces of the stone masonry prisms were scraped and leveled to ensure a smooth contact area. The specimens were placed on the lower platen of the 500 kN capacity Shimadzu testing machine as shown in Figures (8 and 9), Both centroidal axes of the specimen were aligned with the center of thrust of the machine. A uniform load of 8,000 N/min was applied to all specimens until the failure of the specimen. Testing was stopped when an irreversible load drop of more than 50% of the maximum load was observed. The load and displacement data were recorded through a built-in data acquisition system in Shimadzu.

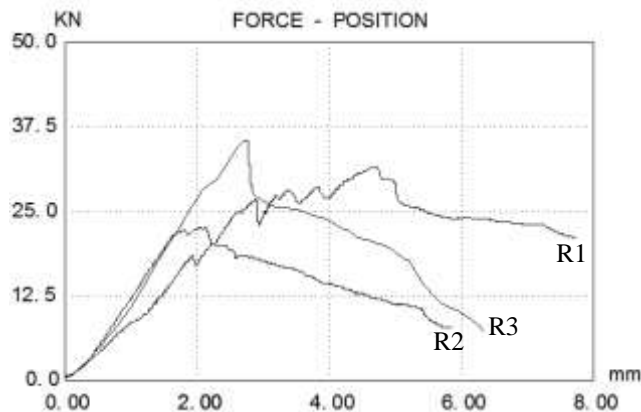
Figure. 15: load - displacement curves of the prisms strengthened with bed joints reinforcement.

It has been observed through the investigation of load-displacement curves of the strengthened stone masonry prisms with bed joints reinforcement (Fig. 15) that the reinforcement of masonry prisms with stainless steel bars embedded in the bed joints grooves did not significantly change the behavior of prisms, where the behavior and shape of the load-displacement curves of the reinforced prisms were somewhat similar to the shape of curves of the un strengthened masonry prisms but with a higher failure load than them. These reinforced prisms also kept their ductility and showed a ductile failure after reaching the maximum break stress value.
